03V-060 ① of ③

SUBJECT: Certain 2000 through 2003 Model Year F53 Chassis - Brake Warning Indicator

SUBJECT: Campaign #88 -Ford® F53 I.P. Brake Warning Indicator

INSTRUMENT CLUSTER BRAKE WARNING LAMP CIRCUIT REVISION

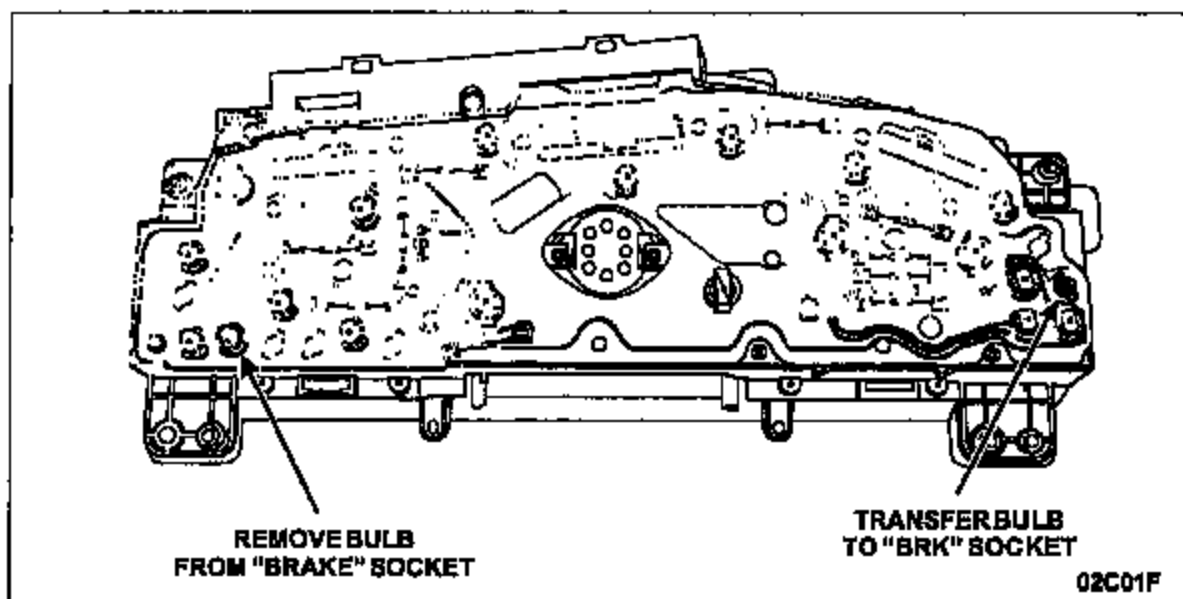
5. The defect involves the Ford instrument panel, which may have a bulb missing from the "BRK" socket. Without the bulb in this socket, the brake warning indicator for a check indicator function and/or a low brake fluid condition will fail to illuminate. The brake warning indicator is intended to illuminate when the ignition key is turned to the ON, RUN, or START position and/or when the brake fluid is low. Federal Motor Vehicle Safety Standard (FMVSS) No. 105 S5.3 [Technical Standards Document (TSD) No. 105 S5.3 in Canada] specifies that this check of the brake warning indicator function and the low brake fluid indication be provided.

7. Install the convolute and retape both harnesses.
8. Remove the bulb from the "BRAKE" socket and transfer it to the vacant "BRK" socket located on the opposite side of the cluster. See Figure 6.
